SUBJECT : OmniSTAR FIRMWARE UPGRADE

APPLICATION : KEE TECHNOLOGIES

DESCRIPTION : IDENTIFYING THE FIRMWARE VERSION

PROCEDURE : ZYNX X10 ZYNX X15 ZYNX X20

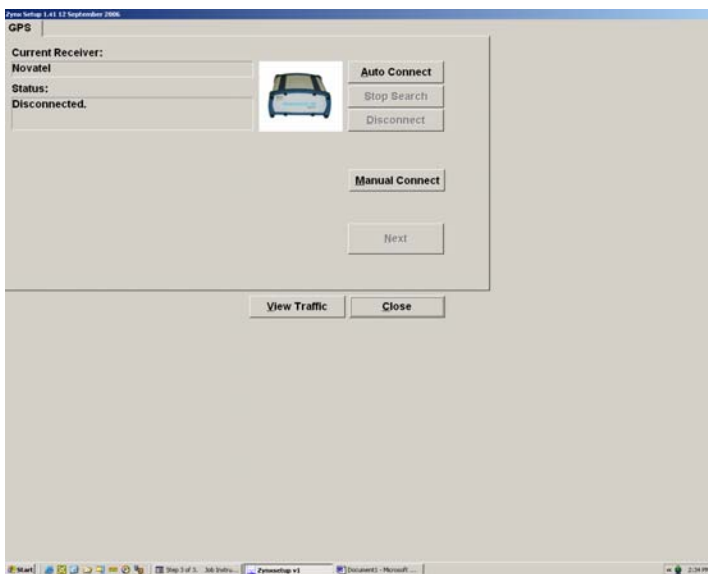
1. Double-click the Zynx set up icon on the Desktop – or press the **SETUP** tab on the X20 when it is loading the guidance program.
2. Press the **AUTO CONNECT** button.

Start Zynx setup and press auto connect

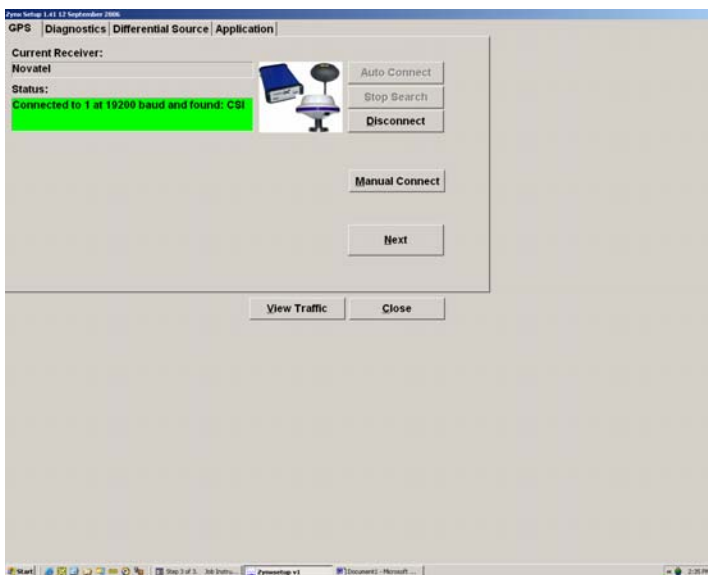
3. Once connected, as indicated by the Status dialog box press NEXT.

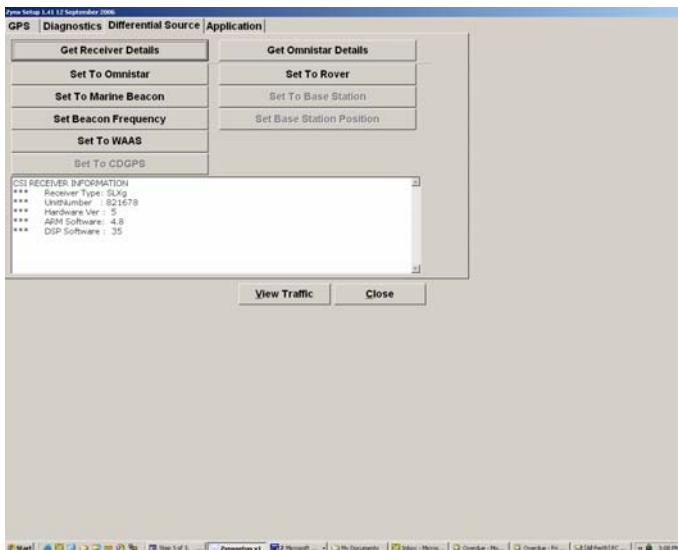
5. The firmware version will be within the reply data.

CSI RECEIVER INFORMATION

*** Receiver Type: SLXg
*** Unit Number : 822547
*** Hardware Ver : 5
*** ARM Software: 4.6
*** DSP Software : 35
